## **SECTION I – INTRODUCTION**

The Platform Hillhouse is located approximately 5.5 miles offshore in the Santa Barbara channel on the Outer Continental Shelf (OCS) just southeast of Santa Barbara, California (refer to Google Earth Image A below and Photograph 1). The Platform Hillhouse was installed on November 26, 1969, and began production on July 21, 1970. It is located in the Dos Cuadras Field on federal lease OCS-P-0240 and is situated in 190 feet of water. In 1997 Nuevo took over the operations of the platform from Unocal. In 2004, Nuevo was acquired by Plains Exploration and Production (Plains), who took over operation of the platform. Plains only ran the platform for a little more than four months and then sold the operation to DCOR in March 2005. Since March 2005, DCOR took over operational control of the Dos Cuadras field including Platform Hillhouse.

**Platform Hillhouse- Marine Sanitation Device (MSD) Inspection: 2014**

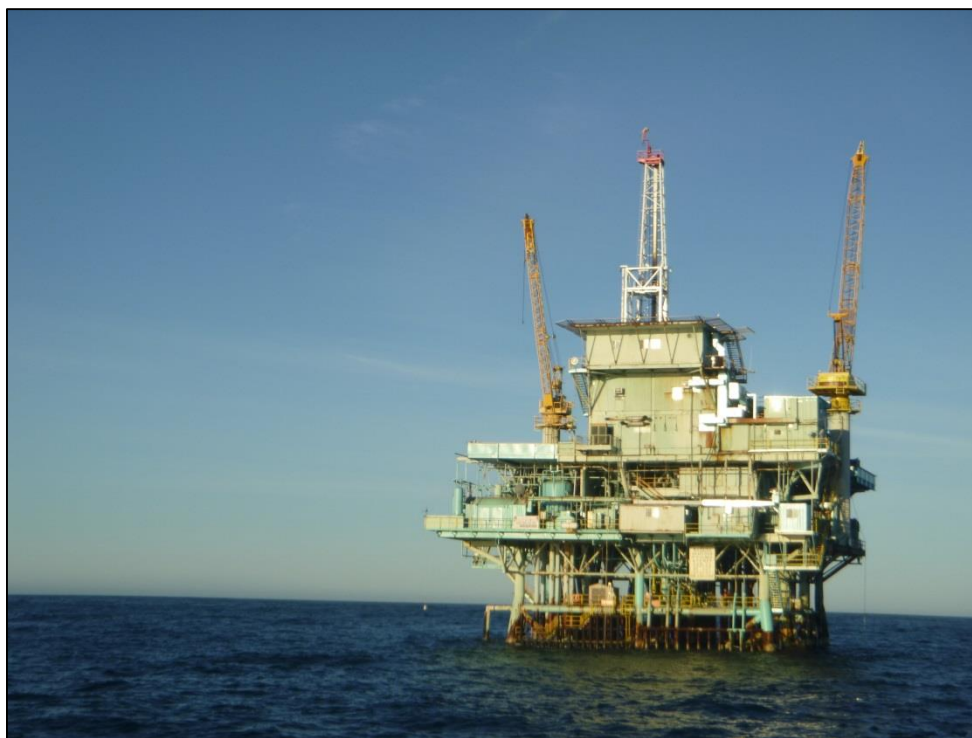
**Photograph 1.** View of DCOR, LLC's offshore Platform Hillhouse.

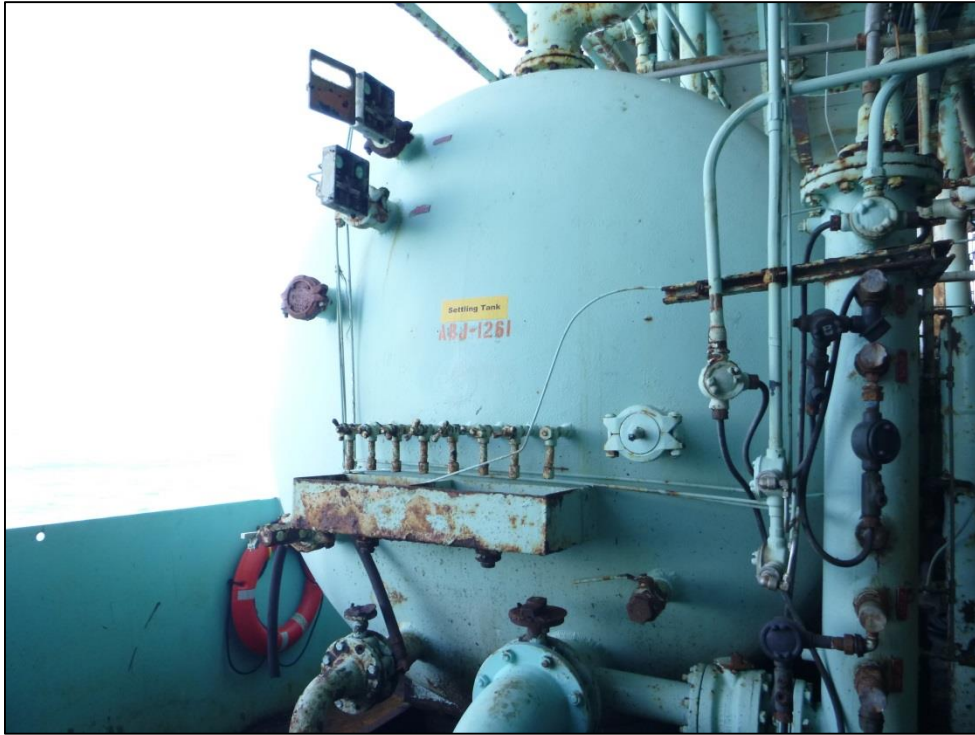
**Photograph 3.** View of old Platform Henry oil treater tank located on the production deck of the Facility. This tank has been repurposed and is now known as the settling tank and receives deck drainage and fire control system water from the sump tank/vessel prior to being commingled with produced water at the WEMCOs.

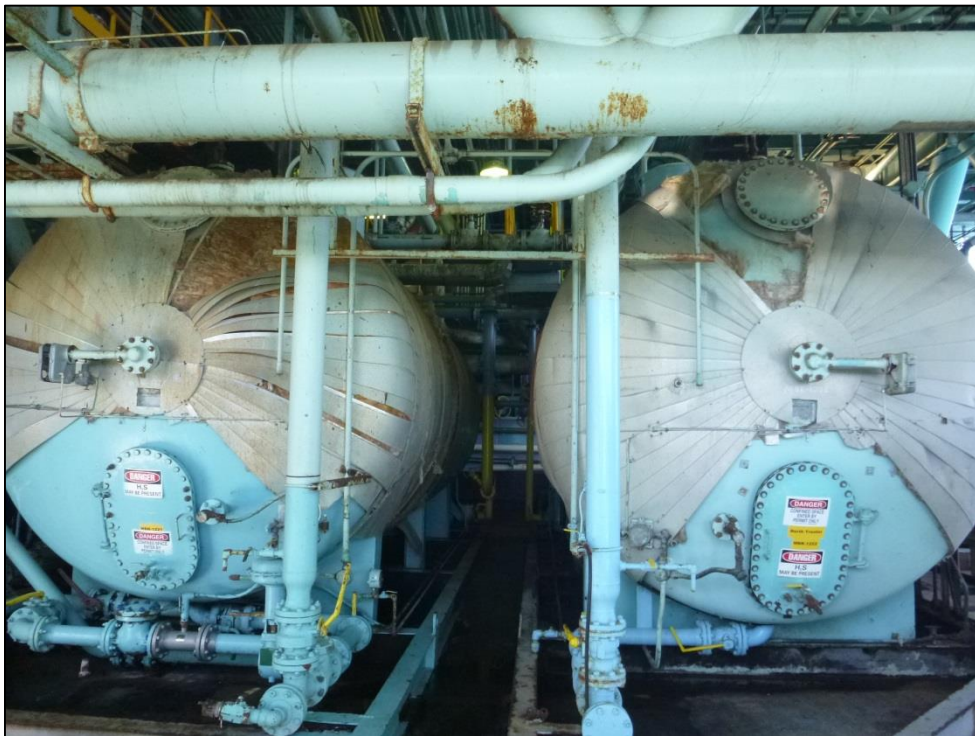
**Photograph 4.** View of two heater treaters (North and South) located on the production deck.

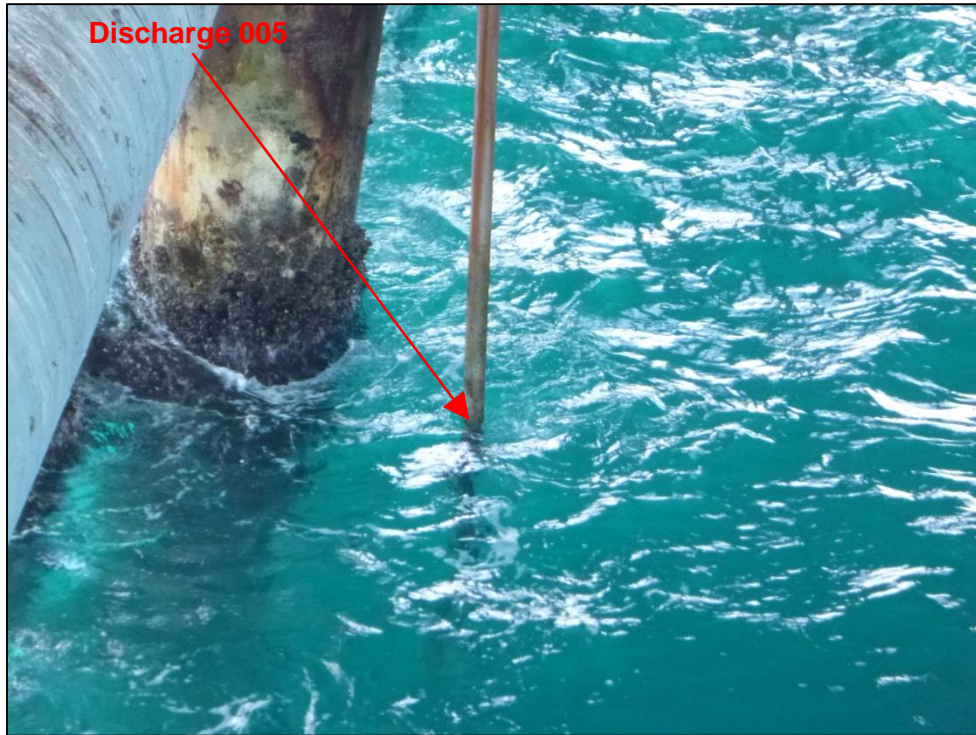
We observed the Facility redFox® MSD used to treat sanitary (black water) wastes (Discharge 005) prior to being discharged to the Pacific Ocean (refer to Photographs 6 and 7). The redFox® MSD unit was stamped with a manufacture date of July 2, 1997.

**Photograph 7.** View of domestic and sanitary wastes discharge point (Discharge 005) to the Pacific Ocean.

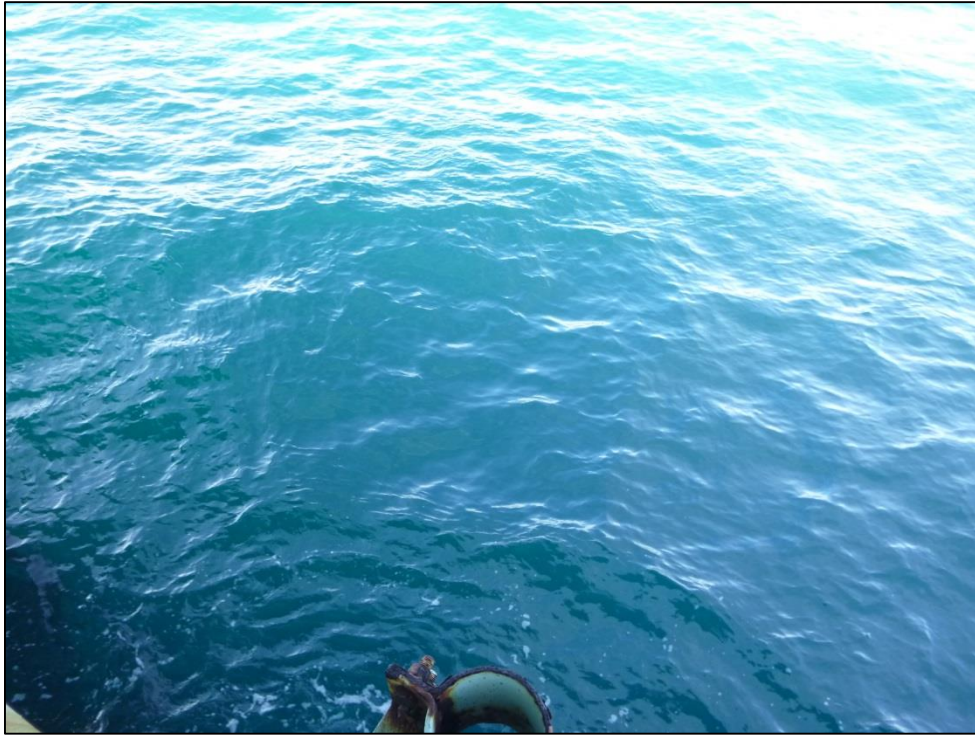
**Photograph 11.** View of the receiving water (Pacific Ocean) within the vicinity of platform Hillhouse at the time of the inspection.

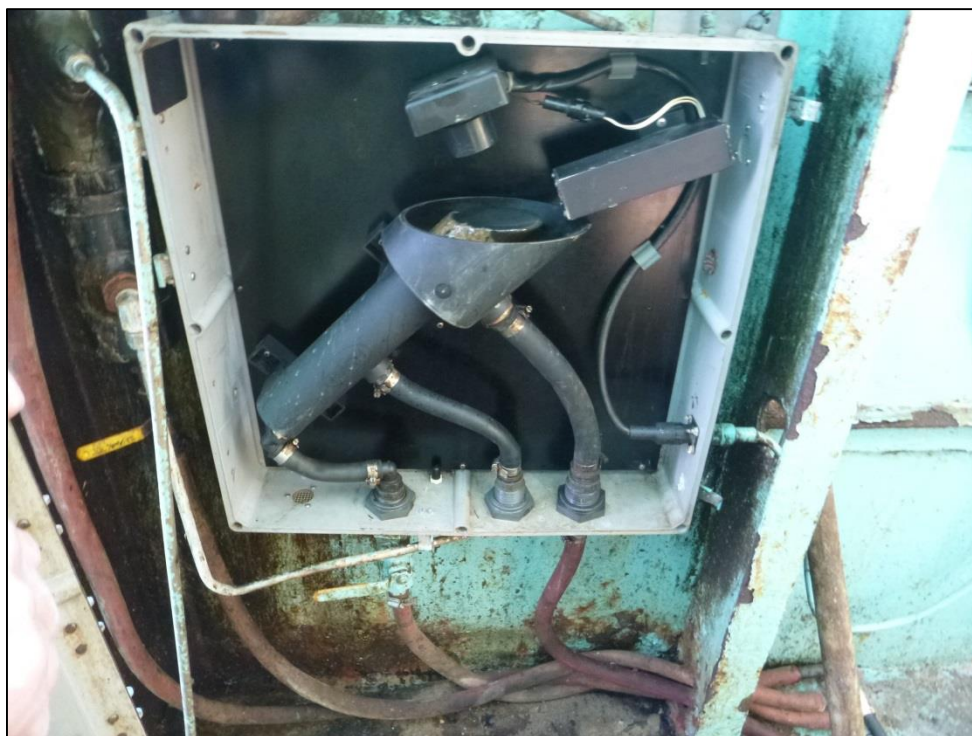
We observed the Facility on-line oil and grease monitor, which was installed in accordance with Part II.G.6, On-Line Oil and Grease Monitors, requirements of the Permit. The Discharger conducts additional internal process monitoring for oil and grease in produced water after the surge tank via continuous inline turbidity measurement utilizing a HACH Surface Scatter® 6 sc turbidimeter (refer to Photographs 12 and 13). At the time of the inspection, we observed the continuous inline turbidity measurement of produced water to be 1.59 nephelometric turbidity units (NTUs). The Facility representatives stated that there is an alarm (visual and audible) that

**Photograph 13.** Close-up view of continuous inline turbidity measurement device, shown in Photograph 12.

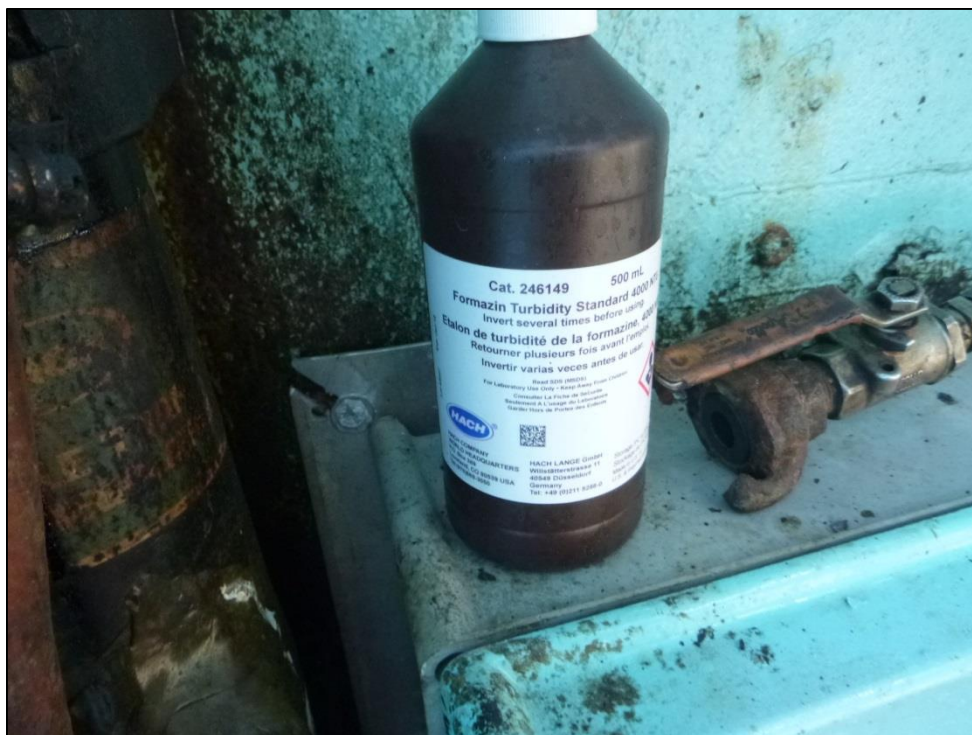
**Photograph 14.** View of a 500 mL bottle of 4,000 NTU formazin turbidity standard solution utilized in calibrating the inline turbidimeter via cylinder method.

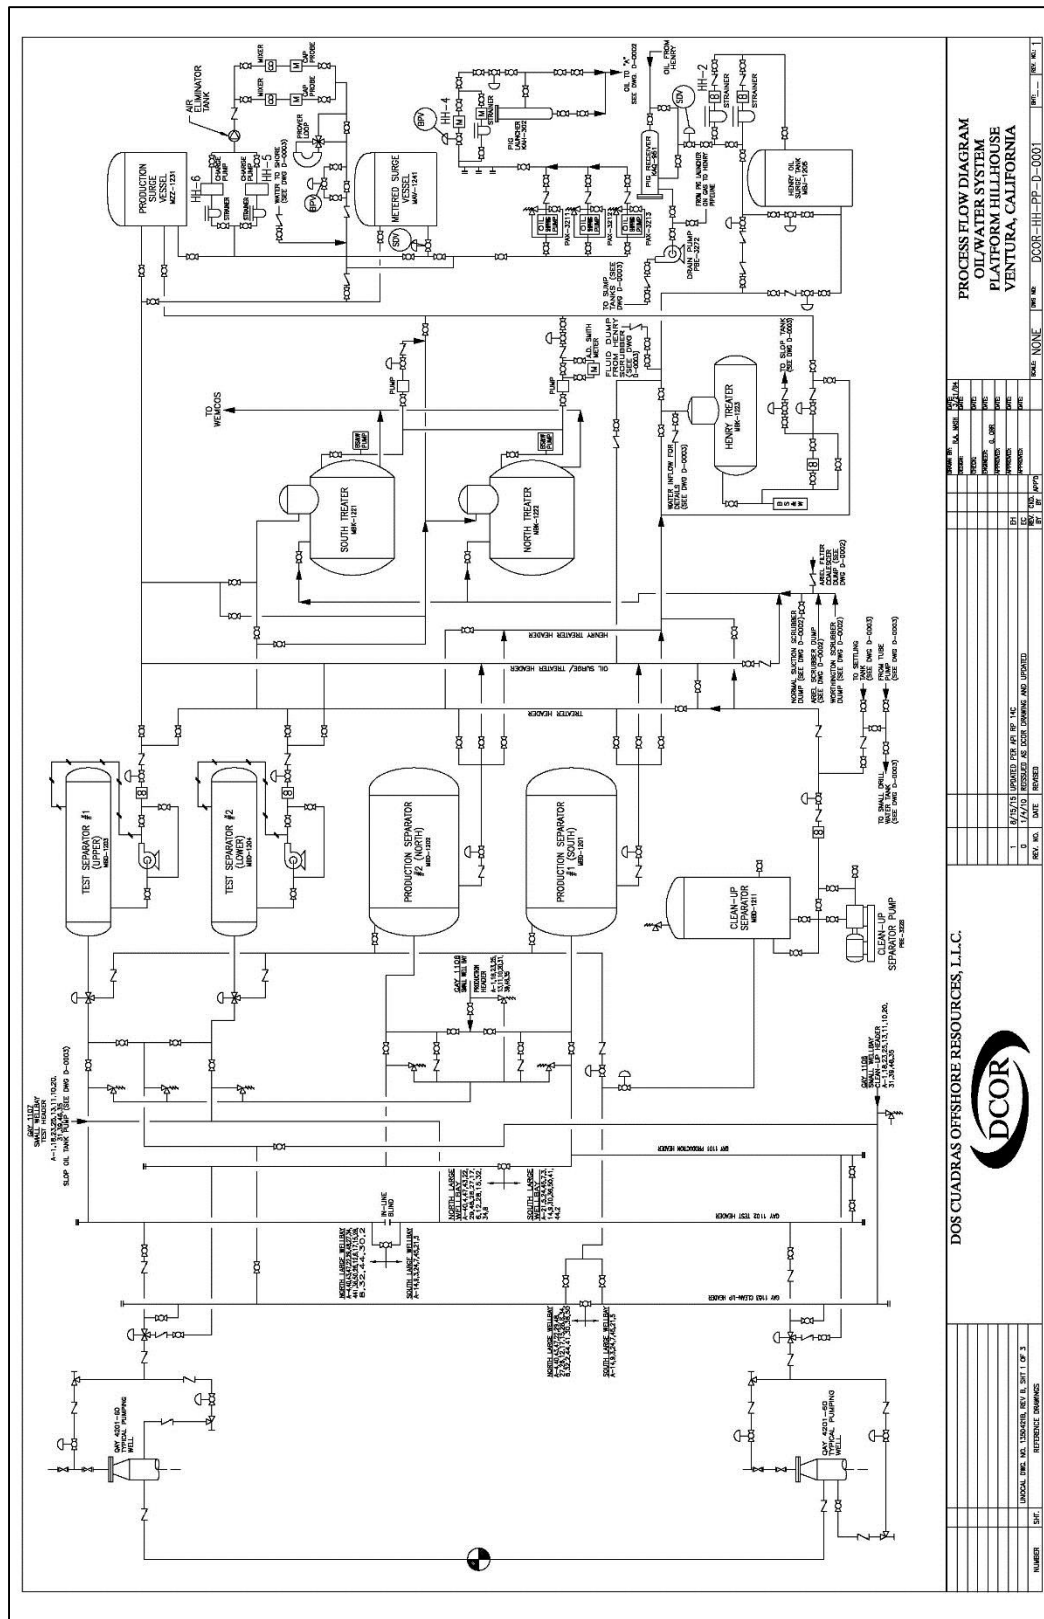
**Exhibit 1.** DCOR's process flow diagram of the oil/water conveyance and treatment system for Platform Hillhouse.
